## CASE STUDY

END USER: Shell

**LOCATION:** Offshore Louisiana, Gulf of Mexico

LINES SIZES AND MATERIAL: 2" NPS 2507 Super Duplex

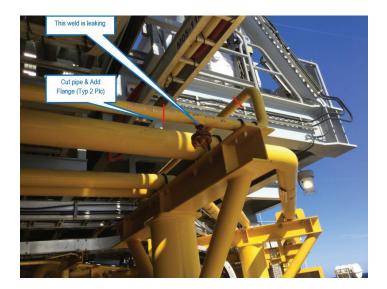
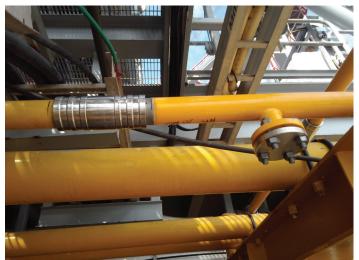
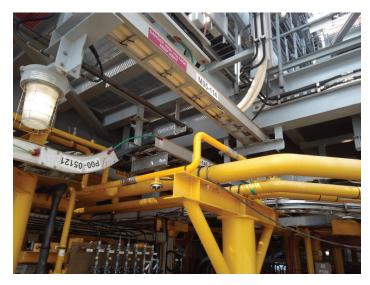
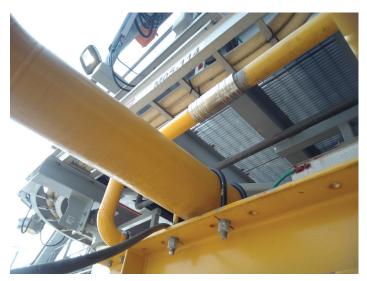
Failed weld on a 2" branch tee was leaking and PYPLOK was selected to perform a non-welded repair offshore on the 2" Sch 10 Super Duplex line. A spool with new tee was fabricated onshore and PYPLOK was utilized to tie in the spool with the exiting line. Service is ASME 150 class service, B31.1, constructed out of A790 UNS S32750/32760 super duplex, under USCG Service Class I jurisdiction, ambient temperature seawater service. Repair was executed quickly and safely with PYPLOK fittings.
