CASE STUDY

END USER: Ibaizabal Group – Crude Oil Tanker "Montesperanza"

SYSTEM MEDIUM: Heating Coil Piping (Steam and Condensate) - 7 Bar (102 PSI)

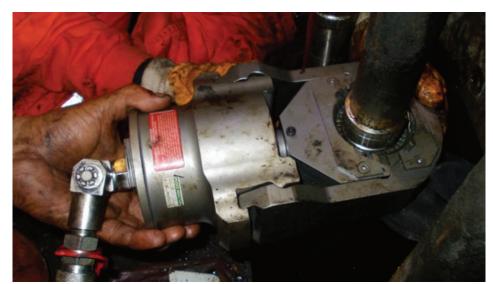
Repair leaking socket weld joints that are leaking steam/ condensate inside fuel tanks on the vessel. Due to the risk and fire and explosion in a confined space with flammable fumes the non-welded PYPLOK fitting was used to execute the repairs quickly and safely.
