CASE STUDY

ExxonMobil

END USER:
ExxonMobil Asia Pacific Pte. Ltd

LOCATION:
Jurong, Singapore

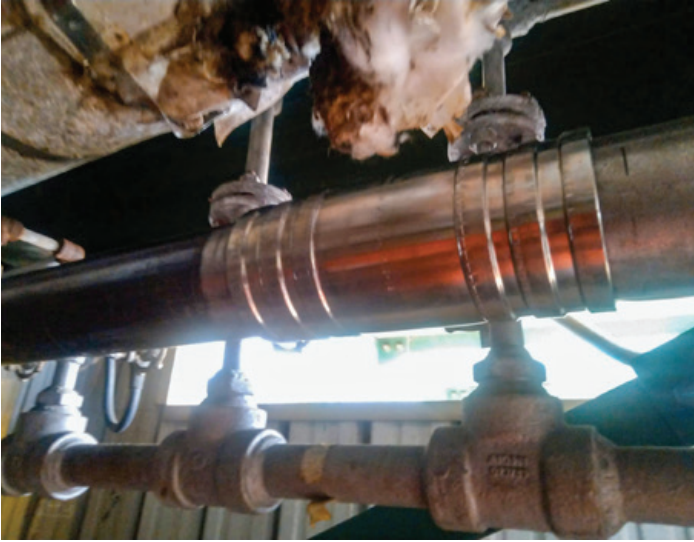
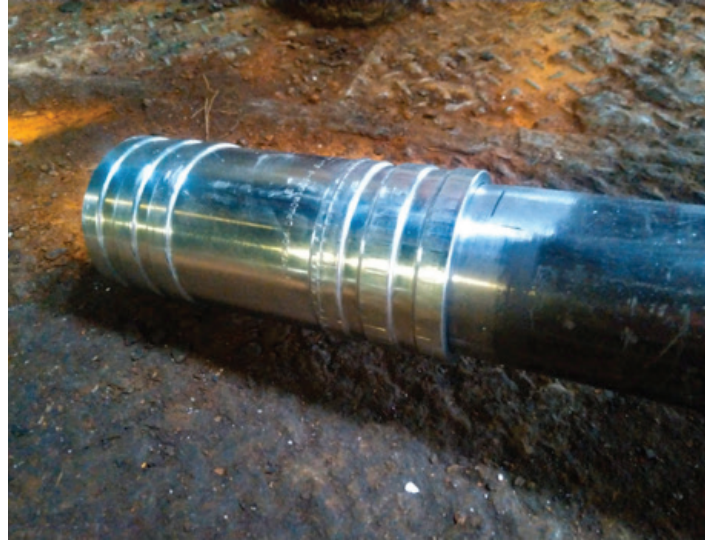
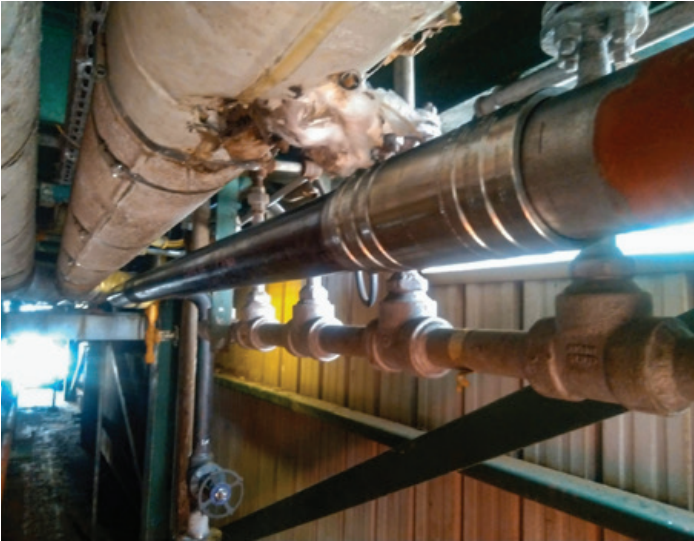
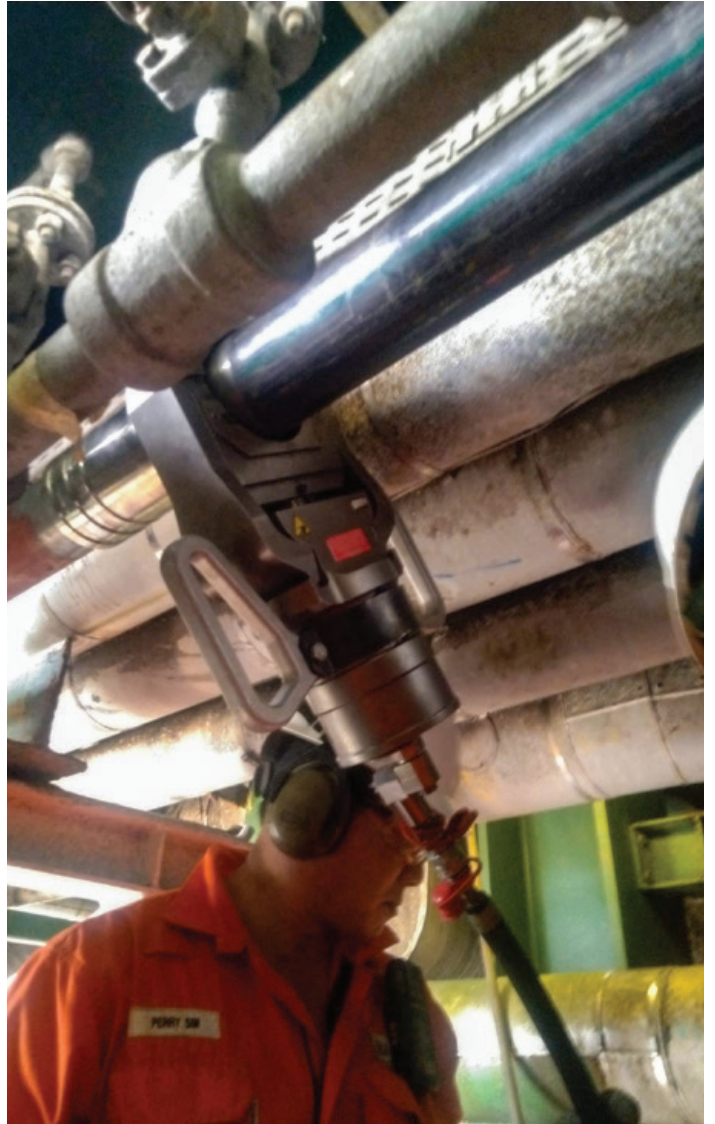
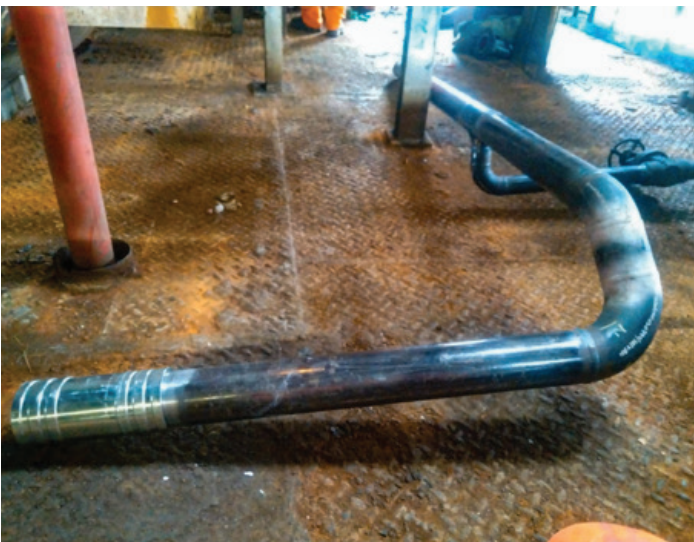
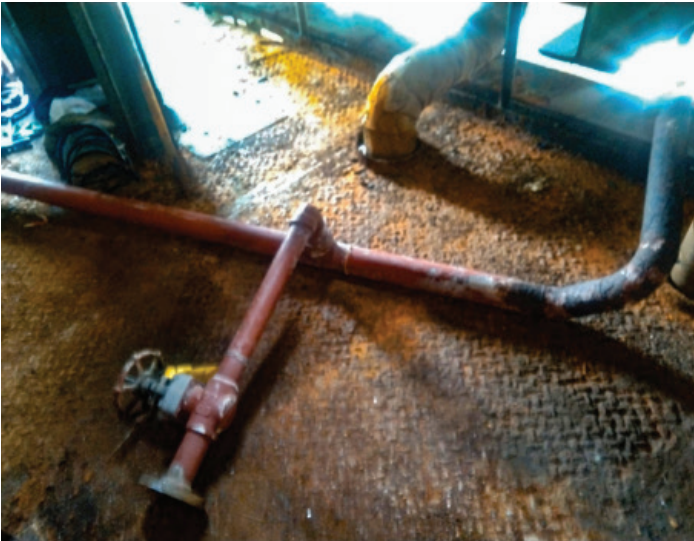
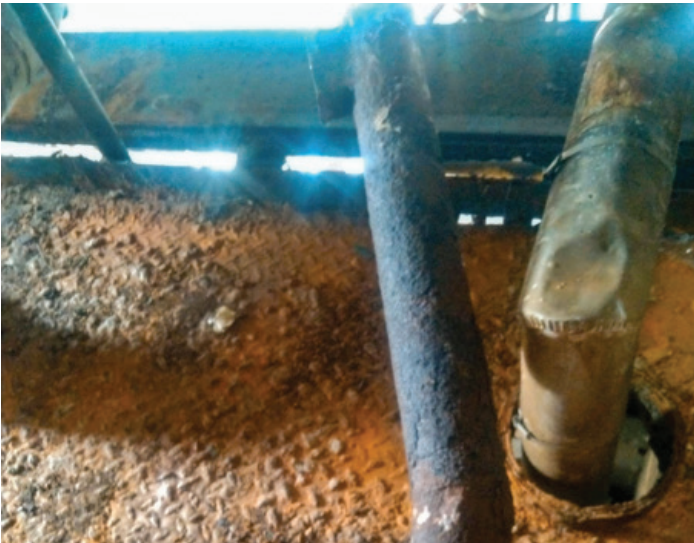
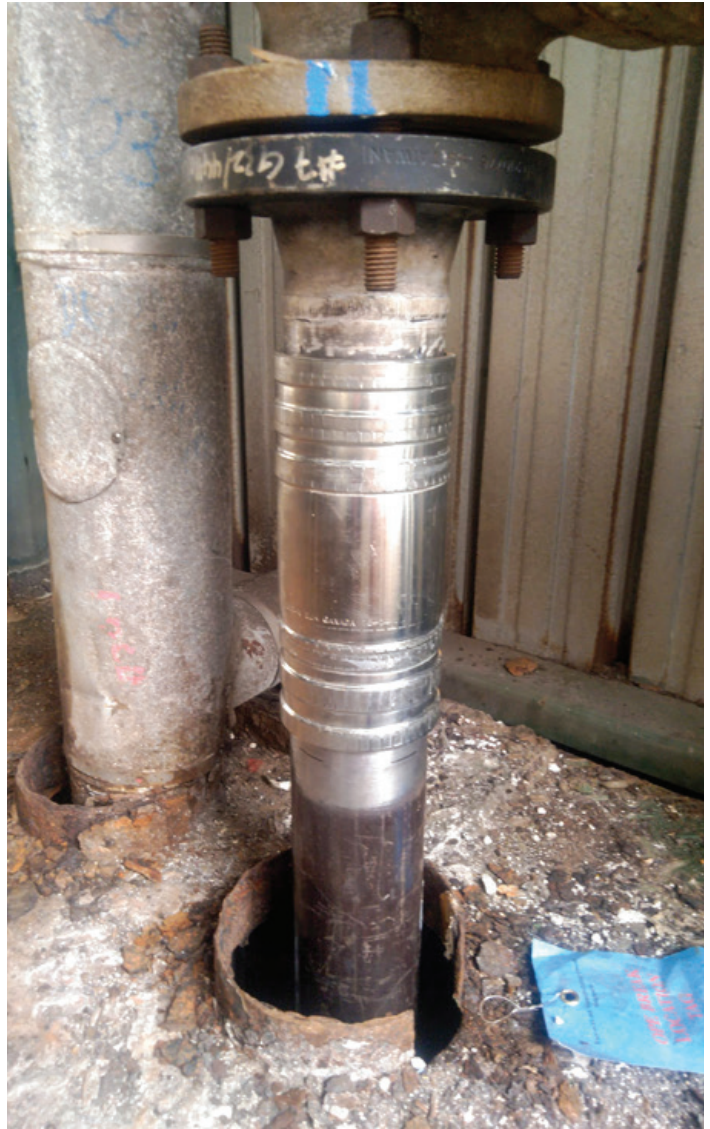
Customer had corrosion in a section of 3" pipe being used for transfer of kerosene. Since the fluid in the pipe was highly flammable and the entire site had specific hot work restrictions, the pipe required a non-welded solution.

Pyplok® was selected for the repair due to the speed of installation and ability to seal on rough, old pipe surfaces in the presence of residual fluid. Removal of old pipe, erection of the new fabricated spool, and final tie-in using Pyplok® was executed safely and rapidly.
