CASE STUDY

VESSEL NAME:
FPSO Cidade de Itajaí

PIPING SYSTEMS REPAIRED:
Chemical injection, bilge, open drain,
thermal oil, water cooling and glycol
piping systems

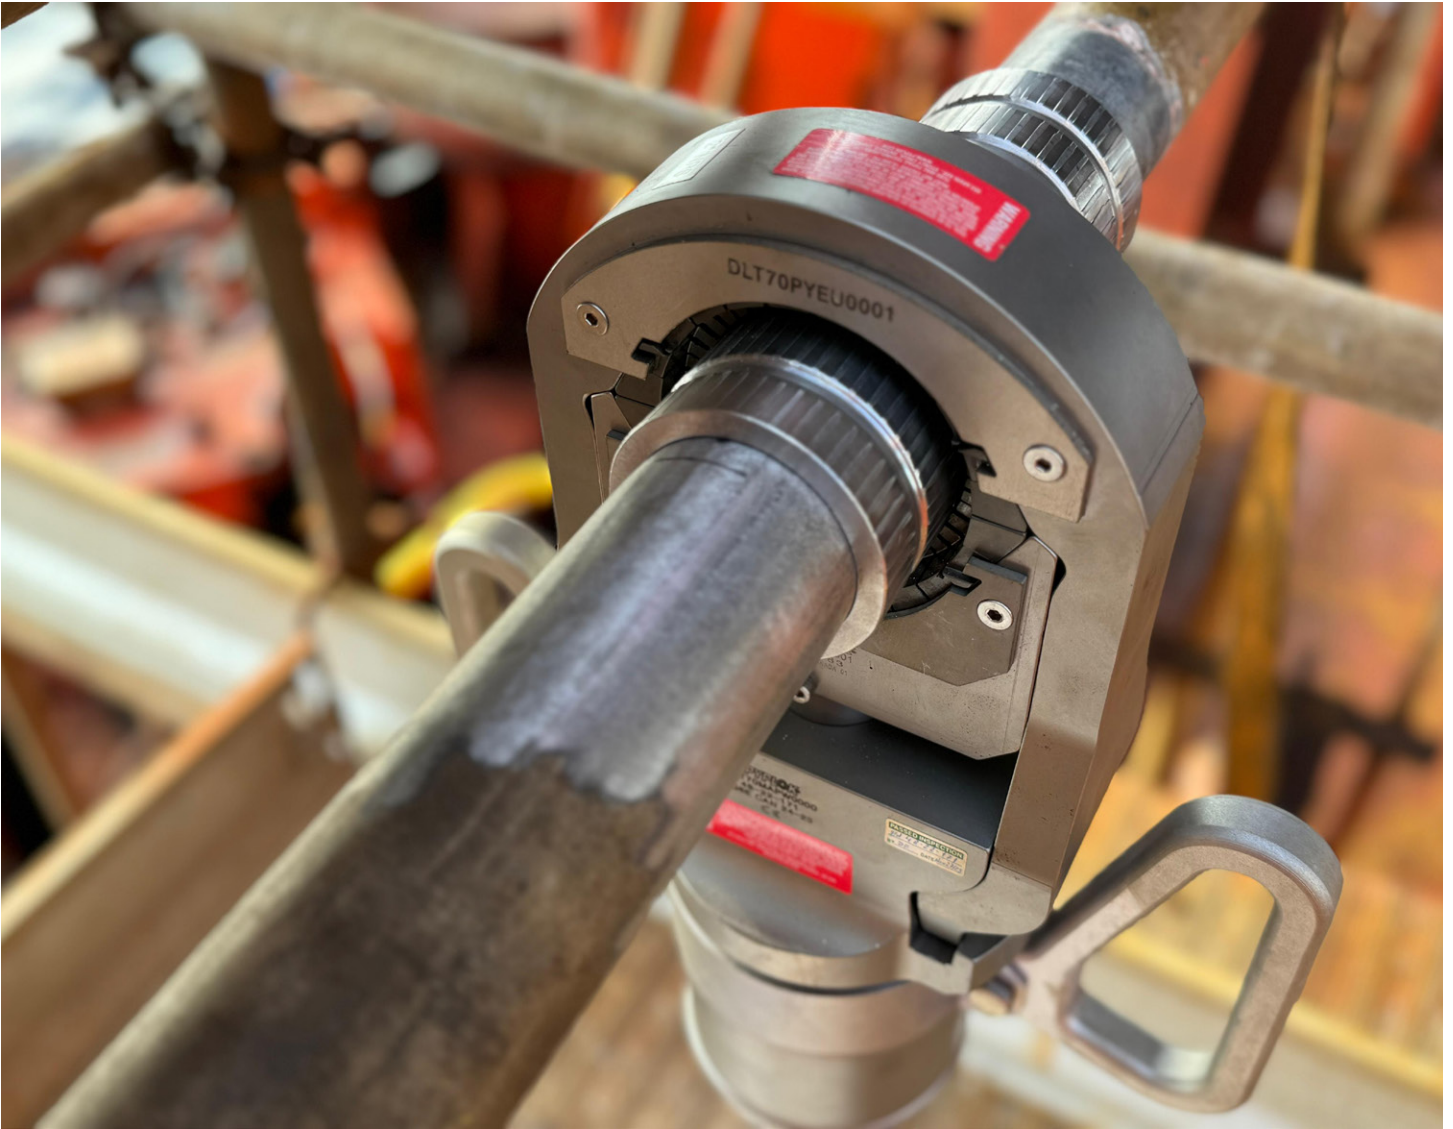
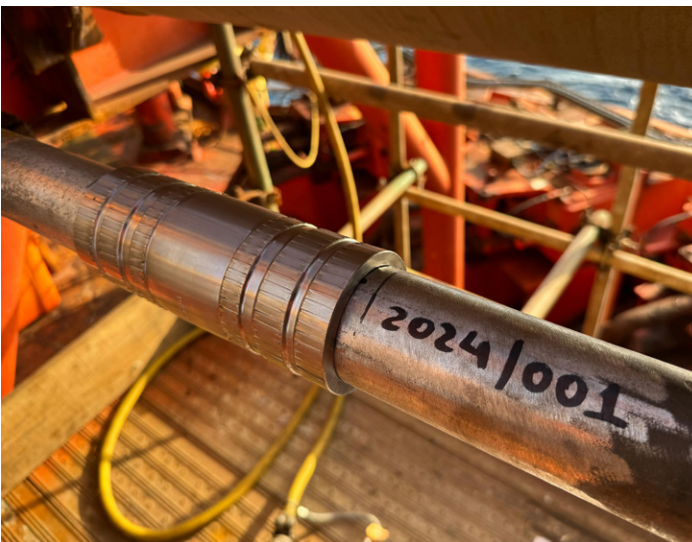
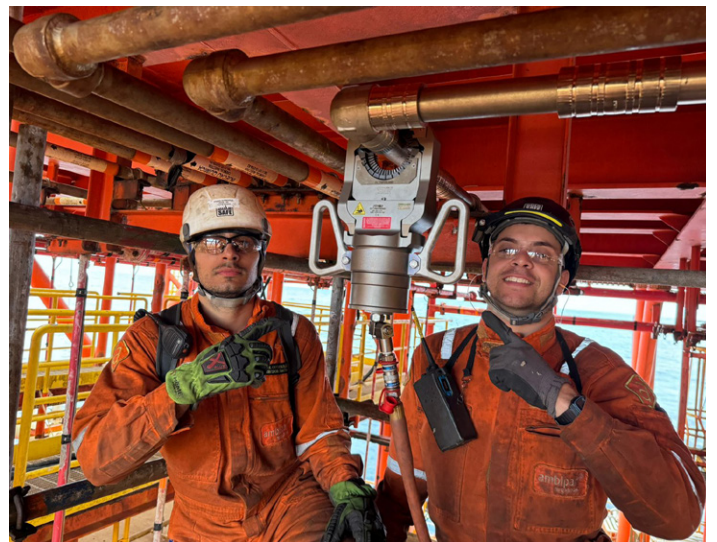
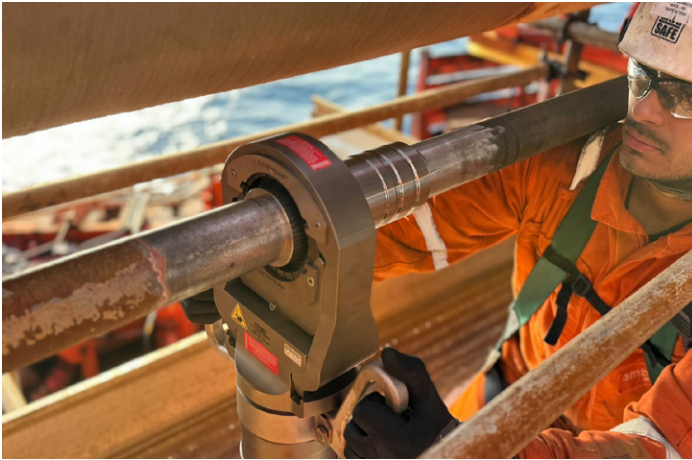
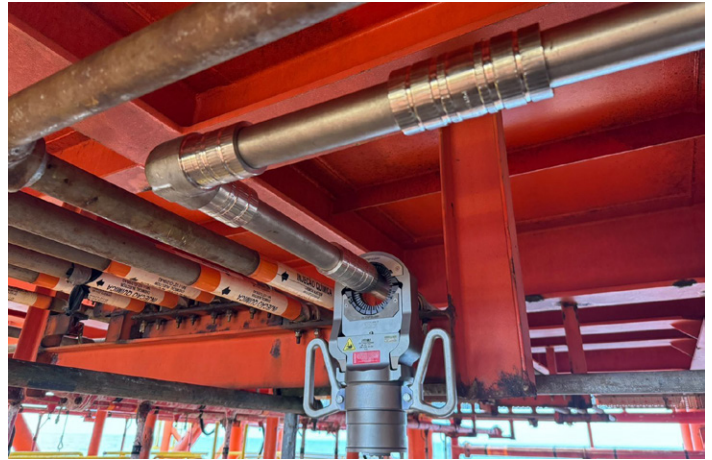
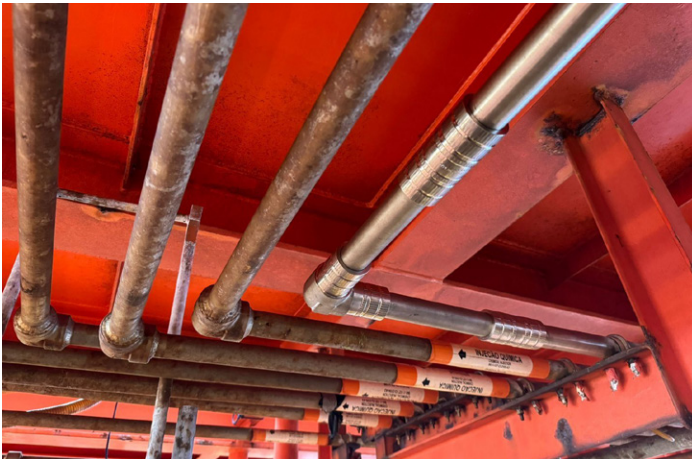
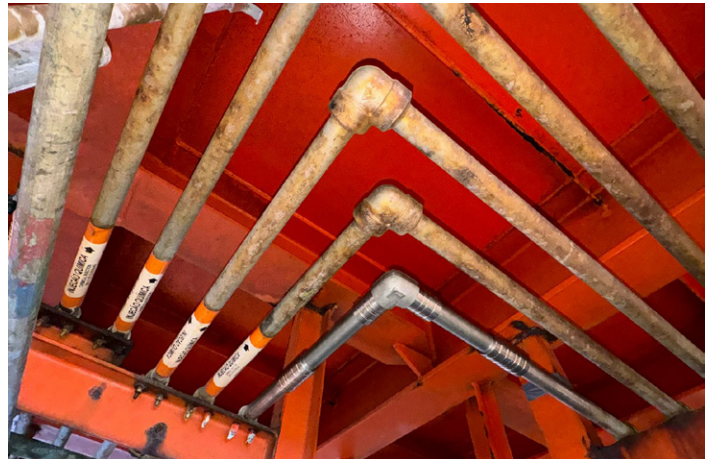
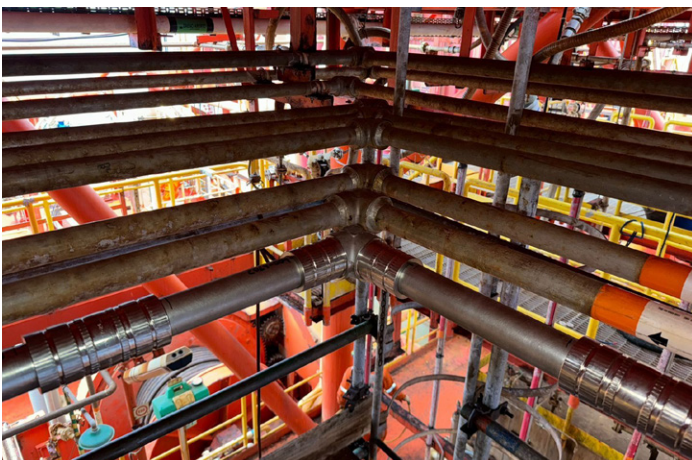
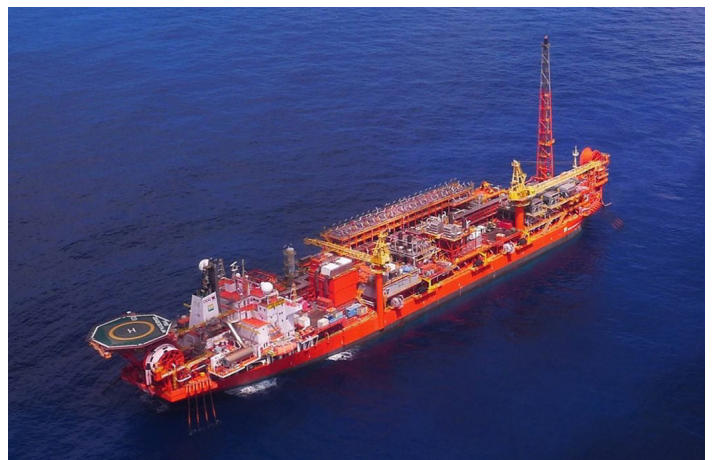
LINES SIZES AND MATERIAL:
1 ½" and 2" Carbon steel
and stainless steel

SPECIAL COMMENTS OR NOTES:
Pyplok® fittings were used for piping repairs on an FPSO during its annual maintenance shutdown, as multiple systems were corroded and leaking at their welds and elbows. Time and personnel are limited on these shutdowns, and some repairs were required in hard-to-reach areas. Pyplok® systems require less time, less manpower, and no hot-work permits, ensuring all repairs could be completed properly during the shutdown.
